EXAMPLE 1. LABORATORY SCALE ACCIDENT WASTE CHEMICALS Chemical research laboratory explosion in a Finnish University Internal accident investigation report Edited by Esa Uosukainen, Aalto University Safety, 2020

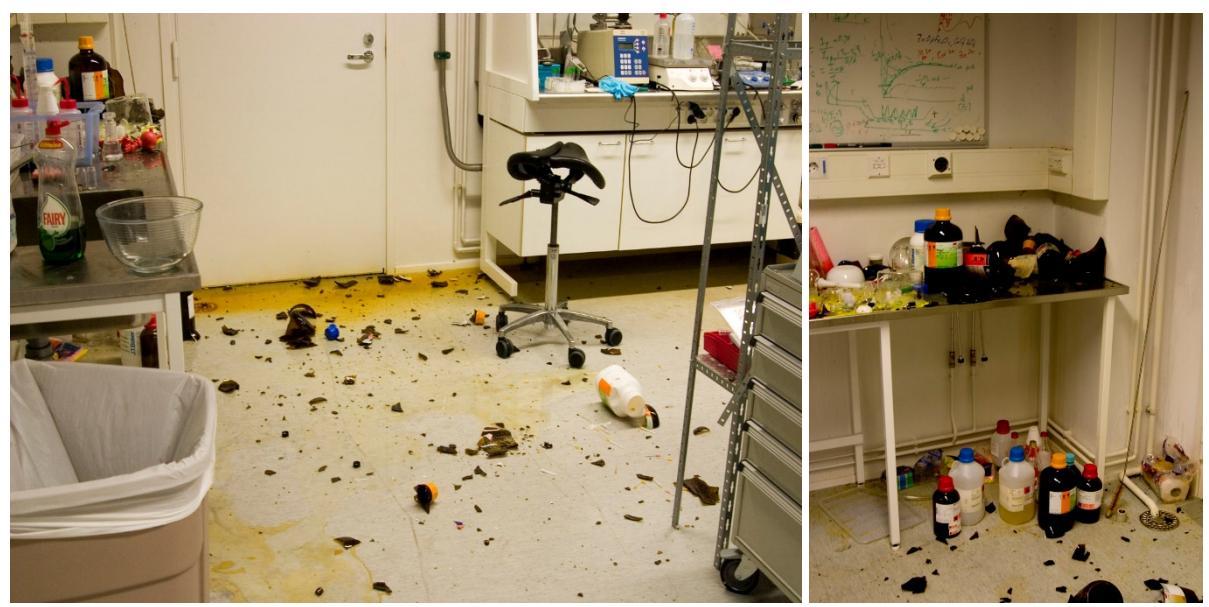
Fig. 1 (left). A washing bottle with acetone is on top of the hot plate in the cupboard. Fig. 2 (right). Chemical waste bottles on laboratory tables and on the floor. Below is a normal drain.

Photographs (Fig. 1 and 2) were taken from the space immediately after the accident. In the nearby laboratory, there was a similar waste chemical collection point. There were written instructions, which chemicals can be combined in the same waste flask. At the explosion site there was no such instructions, nor did the staff explain with certainty how the waste chemicals had been receipted to the same flask. Based on this data and the mapping visit, the probable cause of the explosion could be inferred.

It is noted that the chemicals used constitute many possible explosive pairs. The intensity of the reaction depends on the quantities and concentrations of the substances. These were not found in the mapping. Based on the foregoing, the authors of the report estimated the reaction of the relatively small quantities/dilute solutions in question took place in a 2.5 dm³ chemical glass bottle used as a waste container. The explosion was likely to be a pressure explosion: the glass chemical bottle exploded when the pressure formed by the reaction exceeded the structural pressure of the bottle. Primary explosion broke also some other bottles in the table. This is likely because:

Based on the images and studies in venue, material damage remained also low. In the laboratory, no major mechanical or chemical structural damage abnormal from normal wear was observed after cleaning. There was some corrosion caused by chemicals (acid/base/solvent) in the floor coating and the wall paint of the venue.

Need for harmonization in the accounting, handling and storing of chemical hazardous waste was identified. A successful solution requires written instructions to the level of each research group and laboratory. The authors of the report also recommend systematic mapping and a self-monitoring system for the laboratories. Guidance and periodic follow-up should be centrally managed.

Chemical waste should not be accumulated to laboratories but taken to dedicated chemical waste storage. Chemical waste must be discarded to certified waste treatment plant at least once each year. There should be chemical spill mats available to block the floor drains in case of a larger spill.
